17.0 Slick Rock, Colorado, Disposal Site

17.1 Compliance Summary

The Slick Rock, Colorado, Disposal Site was inspected on May 9, 2007, and was in excellent condition. Minor erosion continues on site; does not threaten disposal cell or site features, repair planned in 2008. DOE dismantled the stock fence around the reclaimed spoils pile. Noxious weeds were sprayed with herbicide; the continued weed control efforts have significantly reduced infestations on the site. The U.S. Energy Corporation uranium exploration drill hole discovered in 2006 just outside of the site boundary was reclaimed; no new activity was observed. No cause for a follow-up or contingency inspection was identified.

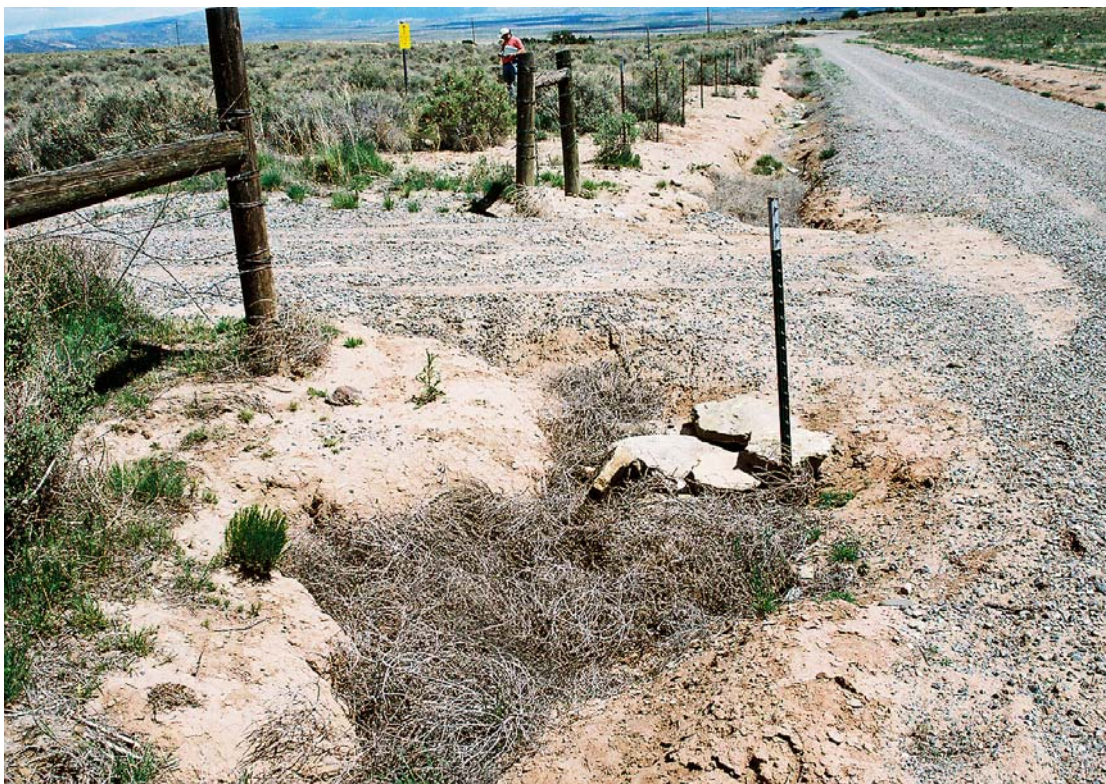
Access Road, Gate, Fence, and Signs—Access to the site is off County Road T11; an improved gravel and dirt road maintained by San Miguel County. The road was in good condition at the time of the inspection. The culvert, installed beneath the access road in 2004 to allow runoff to flow along the borrow ditch, continues to be eroded by stormwater runoff (PL–1). Although it remains functional, repairs will be made in 2008.

SRK 5/2007. PL-1. Eroded culvert filled with tumbleweeds; view of outlet.

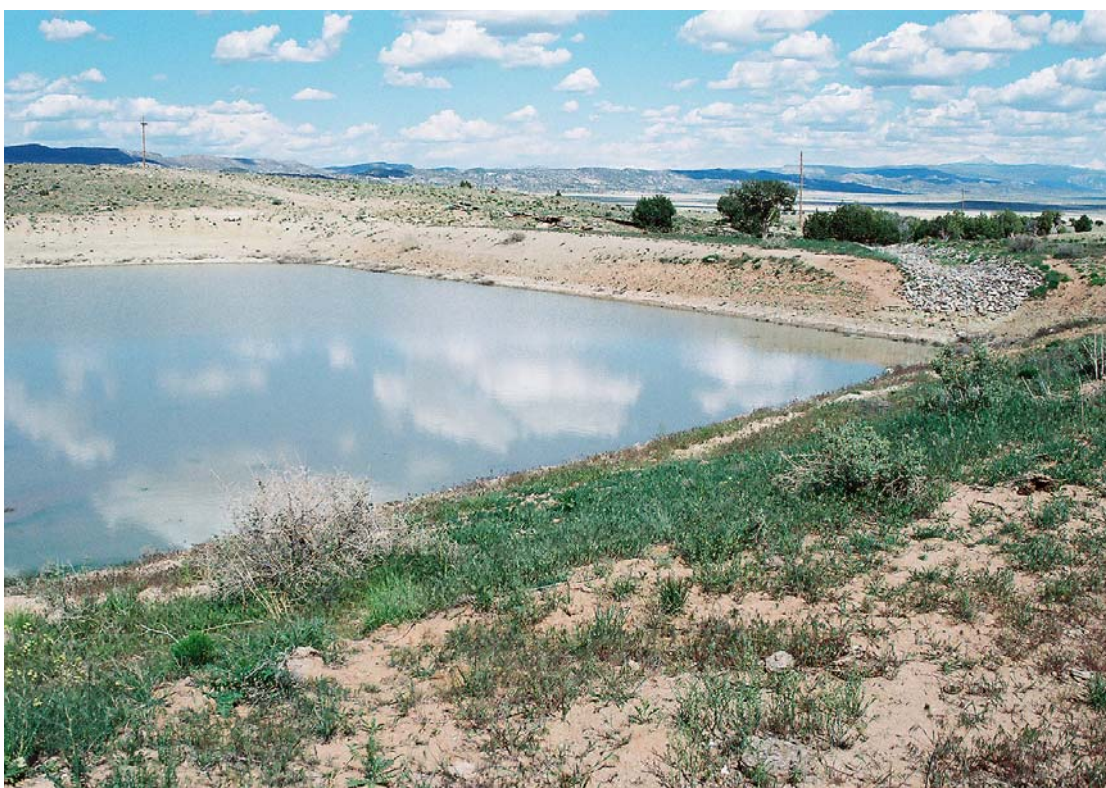
Area Between the Disposal Cell and the Site Boundary—The area around the disposal cell includes the retention pond and the graded and reseeded areas. Surface drainage from the disposal cell flows south into the retention pond, which is constructed in a channel tributary to Joe Davis Canyon. An outflow channel below the pond is lined with rounded cobblestones for a short distance. The pond, which contained water at the time of the inspection (PL-2), and outflow channel were in good condition.

SRK 5/2007. PL-2. Retention pond, filled with water, and outflow channel.

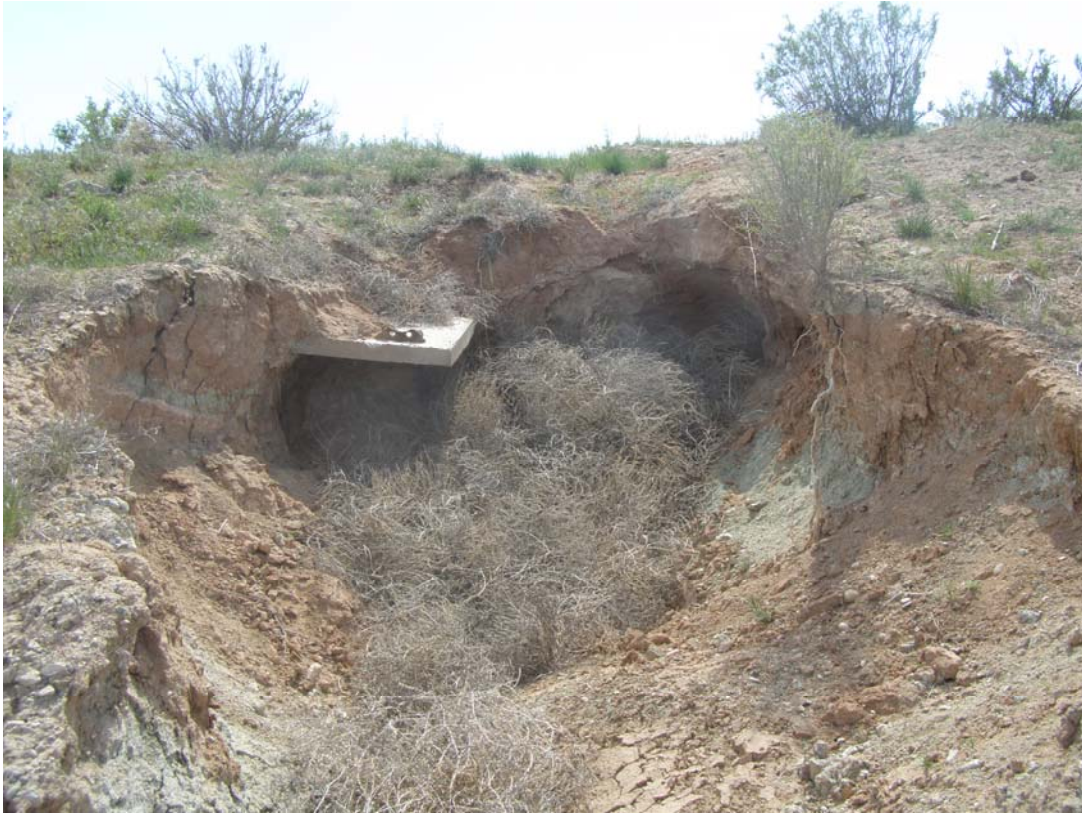
Areas of erosion between the apron and the retention pond were repaired in 2004. The area downslope of the apron is stabilizing, but some erosion is still occurring. Recent storm runoff has increased the size of gullies southwest and northwest of the retention pond. One of the gullies southwest of the retention pond is located approximately 25 feet below the culvert outlet on the county-maintained access road; it is 8 to 10 feet wide and contains a 6-foot-deep, vertical headcut (PL-3). A short distance to the southeast is a second gully containing a headcut that is approximately 3 feet deep. Both of these headcuts will require repair in 2008. Some of the gullies on the northwest side of the retention pond are as deep as 30 inches, but they do not present a hazard to the disposal cell or to a site feature, so action is not warranted at this time. All the erosion areas will continue to be monitored.

SRK 5/2007. PL-3. Gully southwest of retention pond with 6-foot vertical headcut, filled with tumbleweeds.

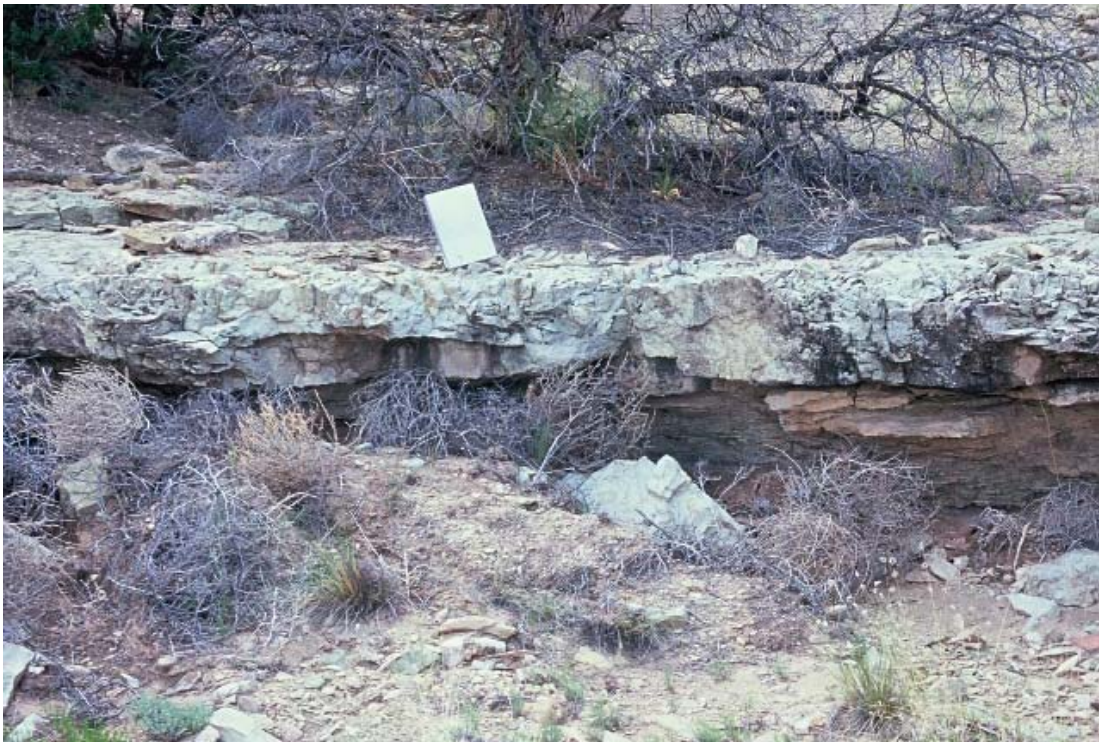
The Kd-1 sandstone unit (Dakota sandstone), which crops out near the northeast corner of the property, was identified in the LTSP as a potential pathway of lateral migration of transient drainage from the disposal cell. Minor erosion of the surface had taken place along the outcrop, where fresh chunks of rock were observed to have broken off (PL-4). However, there was no evidence of moist soil, mineralization, or phreatophyte vegetation that would indicate that transient drainage is occurring along this interface.

SRK 5/2007. PL-4. Dakota sandstone outcrop (Kd-1 sandstone unit).
